**TECHNICAL BULLETIN****[ 1 / 4 ]**

[Issue No.] FA-A-0186

[Title] Improvements in CC-Link IE Field Network specifications for momentary data link error in all the stations

[Relevant Models] RJ71GF11-T2, RJ71EN71, QJ71GF11-T2, LJ71GF11-T2,  
Q81BD-J71GF11-T2, Q80BD-J71GF11-T2

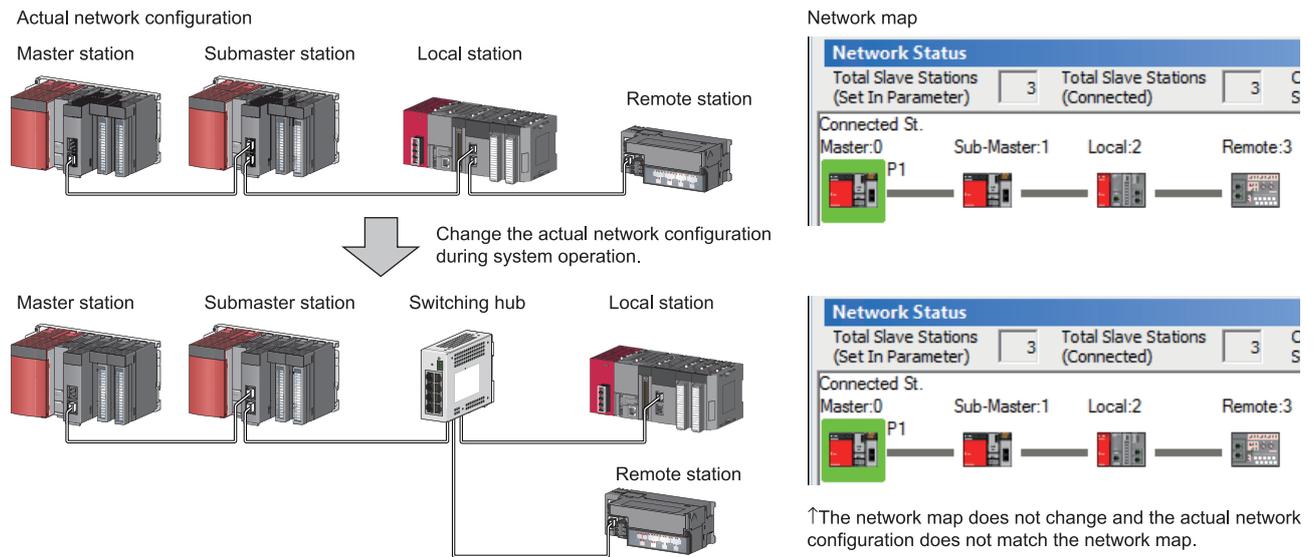
Example: When the actual network configuration is changed from line topology to coexistence of star topology and line topology

With the improvements in specifications, when operation described in "2. Description" is performed, the actual network configuration and the network map of the CC-Link IE Field Network diagnostics may be a mismatch.

When using a ring topology, the following may be occurred.

- The station number of the loopback station cannot be detected correctly.
- Even if a switching hub is used, data link does not stop.

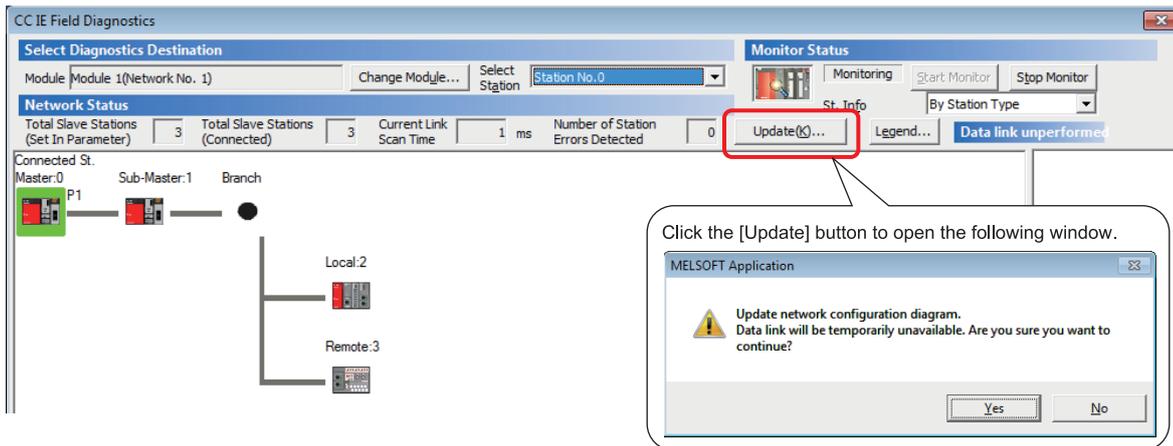
A data link error will momentarily occur in all the stations since all stations on the network will be reconnected when executing the network map update.

To match the network map with the actual network configuration, click the "Update" button\*1 in the CC-Link IE Field Network diagnostics.

\*1 For GX Works2 Version 1.530C or earlier or GX Works3, click the "Delete Disconnected Station" button.
