TECHNICAL BULLETIN

[Issue No.] T40-0007

[Title] Corrections in the QnPRHCPU User's Manual
(Redundant System)

[Relevant Models] Q12PRHCPU, Q25PRHCPU

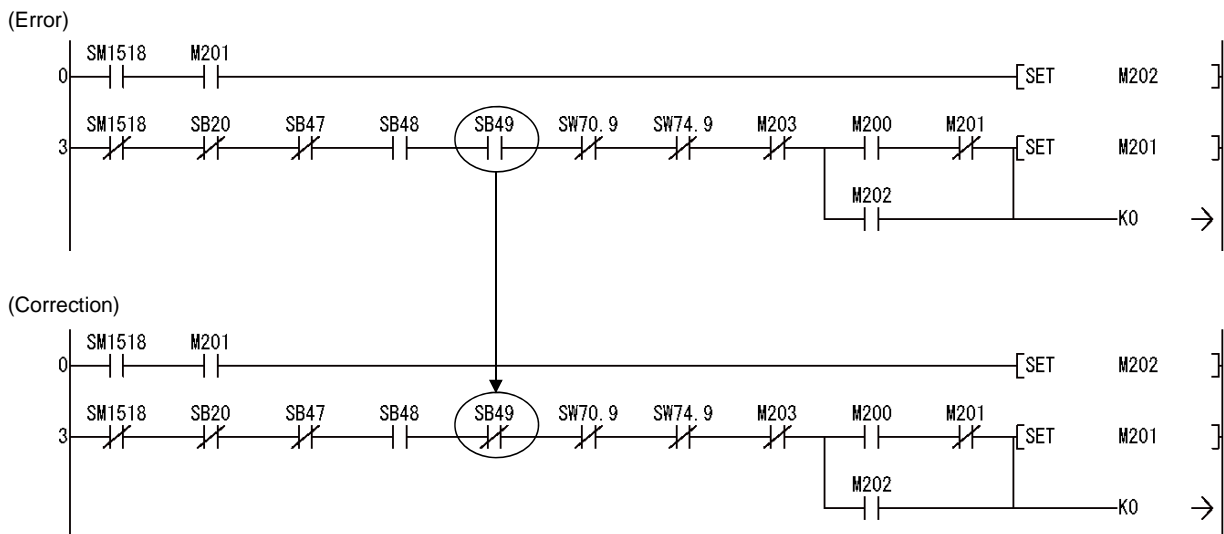
- (1) Section 7.1 (1) (b) [Diagram 7.2 Example of REMFR instruction programming]

The setting condition for the host data link status has been corrected in the example of a program for reading intelligent function module data of the remote I/O station using the REMFR instruction as shown below.

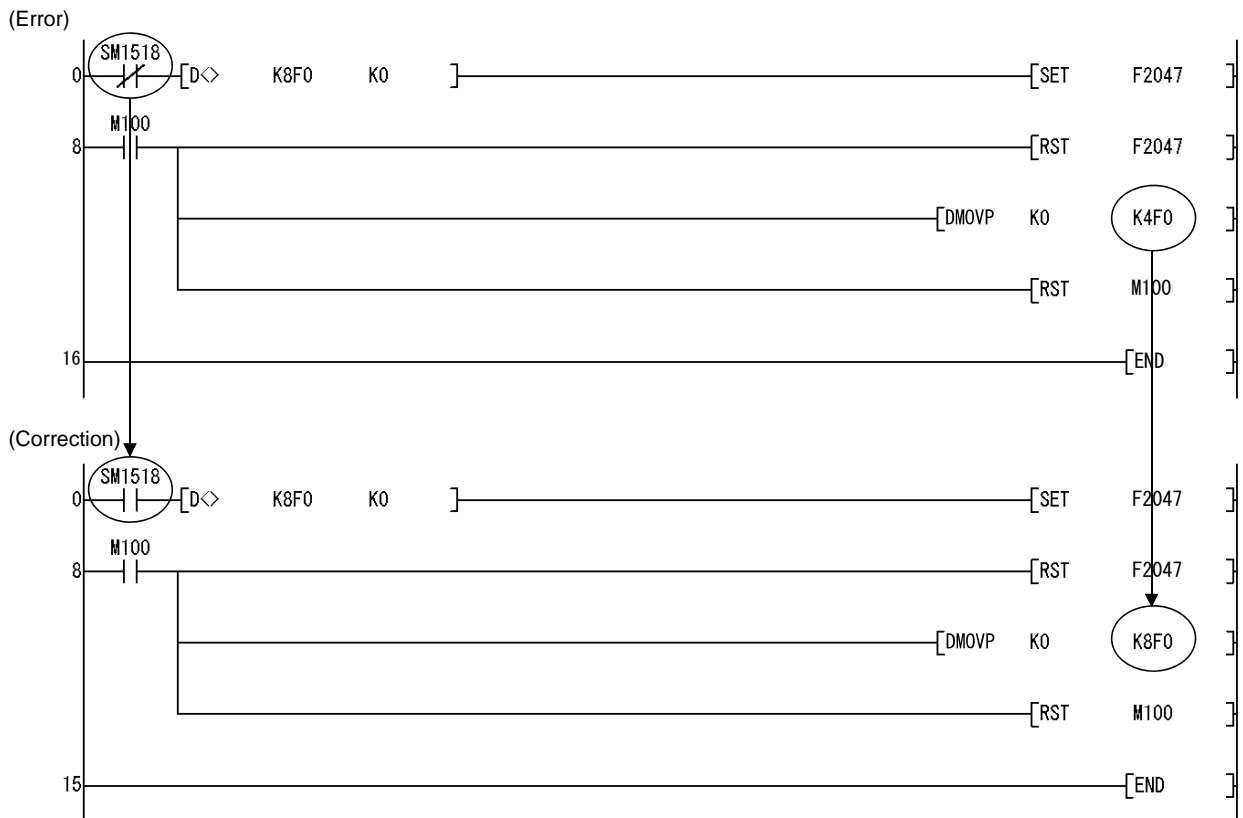
- (2) Section 7.3 (1) [Diagram 7.13 Program That Turns on the "USER" LED after System Switching]
 The SM1518 contact and the storage destination device of the DMOV instruction have been corrected in the example of a program for turning ON "USER" LED on the CPU module in the new control system after switching as shown below.

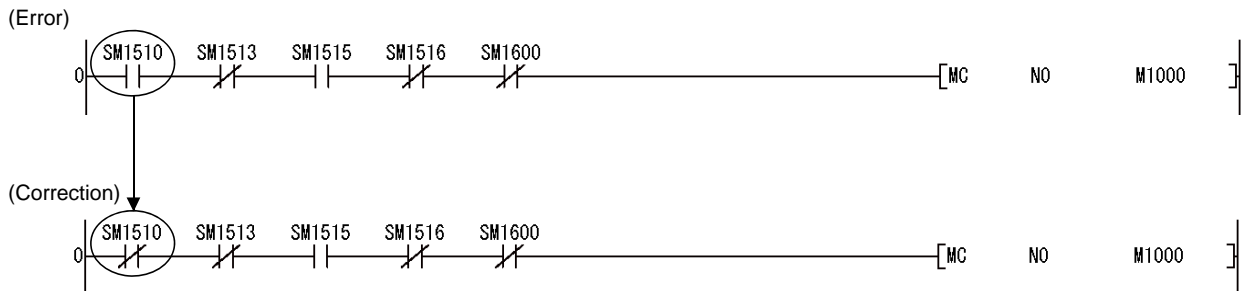
- (3) Section 8.2 (2) (c) [Diagram 8.10 Sample Program for Clearing Standby System CPU Module Error]
 The SM1510 contact has been corrected in the example of a program for clearing errors of the CPU module in standby system as shown below.

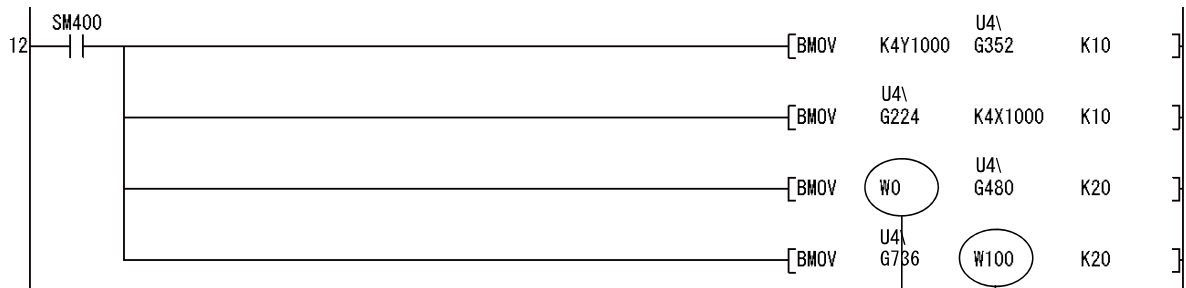
(Error)

(4) Appendix 4.5 (1) (a) 2) [Diagram App.7 A sample program of CHANGE]

The head device number in the remote register has been corrected in the example of a program when using CC-Link as shown below.

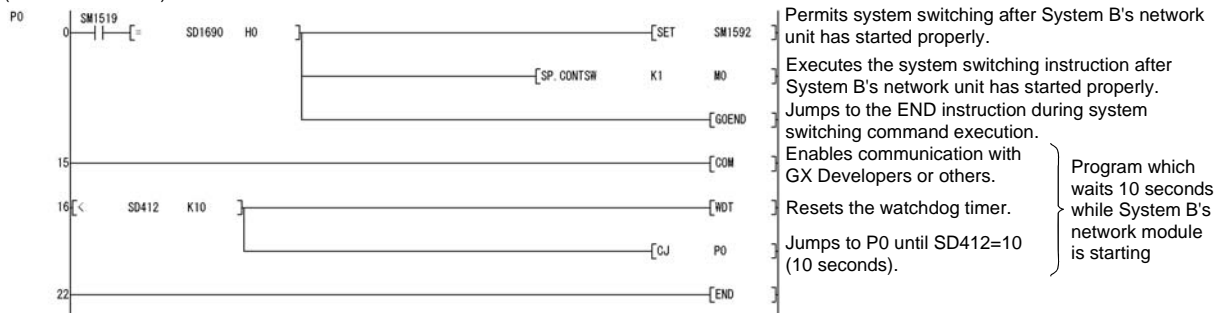
(Before correction)

(5) Appendix 5 (2) [Diagram App.20 A program example]

When 32768 seconds (around 9.1 hours) elapses after the CPU module became RUN status, SD412 value will be -32768. In the following program (before correction), since the processing is repeated in the relevant program until the SD412 value will be 10 or more again (around 9.1 hours), other sequence operations cannot be performed. Note when this occurs, the CPU module will not be STOP status even the RUN/STOP switch is set from RUN to STOP.
