DrEnergy

Who would have thought that the management of energy could lead to more efficient maintenance processes and the increase of plant safety? That was exactly the result of this e-F@ctory application created by Nitto Denko Corporation at their Kameyama Plant 2.

case study

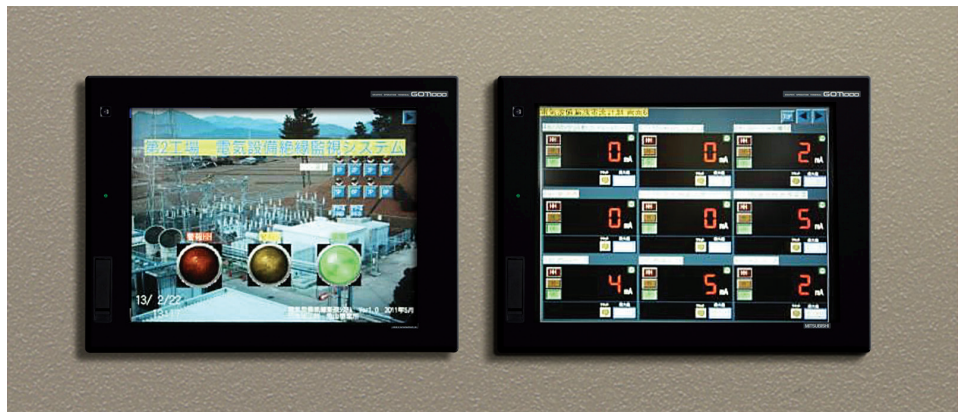
Main display screen (left) and individual monitoring results display screen (right) on the GOT. Values exceeding the set threshold values light up in yellow or red.

Measurement results are displayed on the GOT (Graphic Operation Terminal) display. The QE82LG allows two types of alarm threshold value to be set; in this case Nitto set an electric-shock level of 30mA and a potentially fire causing leakage-level of 200mA. If any of the total 52 monitoring devices should exceed these levels, even once, the GOT displays the leakage point in yellow or red and emits a warning.

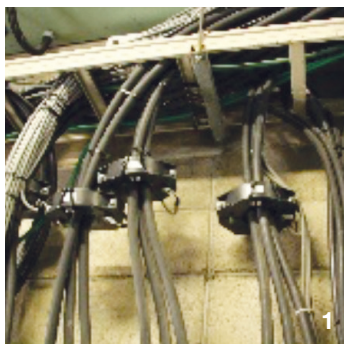
The ZCT (1) mounted on the cables at the base of the panel board sends leakage current information to the insulation monitoring module "QE82LG" (2) within the panel board for processing.

Nitto placed 30 QE82LGs in the transformer room and 22 in the cubicles of its Plant 2. The Zero-phase Current Transformer (ZCT) mounted on the cables at the base of the panel board is used to send leakage current information to the QE82LG which processes it.
