**TECHNICAL BULLETIN****[ 1 / 4 ]**

[Issue No.] FA-A-0186

[Title] Improvements in CC-Link IE Field Network specifications for momentary data link error in all the stations

[Relevant Models] RJ71GF11-T2, RJ71EN71, QJ71GF11-T2, LJ71GF11-T2,  
Q81BD-J71GF11-T2, Q80BD-J71GF11-T2

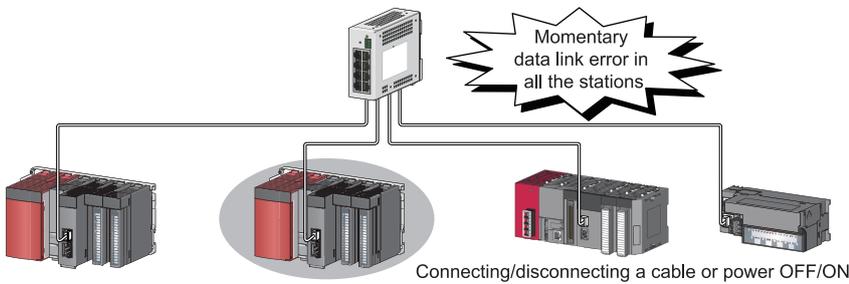
The specifications are improved to prevent momentary data link error occurred in all the stations when the operations listed below are performed in CC-Link IE Field Network.

Network configuration	Operation
Star topology	<ul style="list-style-type: none"> <li>• Powering off and on a slave station or switching hub</li> <li>• Connecting/disconnecting an Ethernet cable connected to the switching hub</li> <li>• Disconnecting an Ethernet cable from a slave station and connecting it to another slave station or a switching hub</li> <li>• Disconnecting more than 9 stations, or half the number of slave stations or more in the system</li> <li>• Changing the network topology when adding a slave station</li> </ul>
Line topology, ring topology	<ul style="list-style-type: none"> <li>• Simultaneously powering off/on multiple stations</li> <li>• Simultaneously connecting/disconnecting Ethernet cables to/from multiple stations (When a data link faulty station returns, a data link error will occur in all the stations.)</li> <li>• Disconnecting more than 9 stations, or half the number of slave stations or more in the system</li> <li>• Changing the network topology when adding a slave station</li> </ul>
